Inspection Report

CPF Home Inspections, LLC

1234 Main St
Kirtland, Ohio 44094

1 Report Information

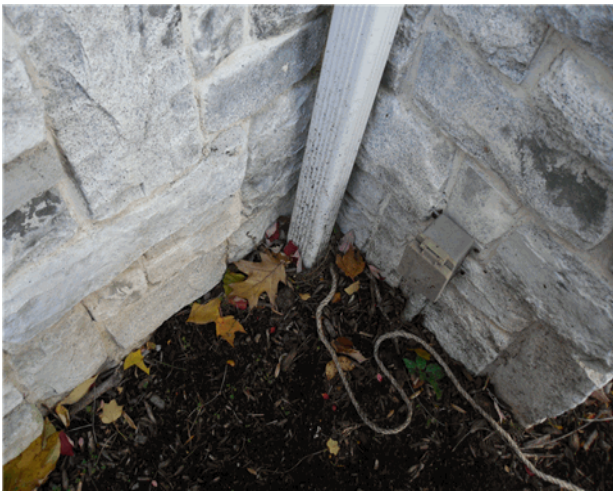
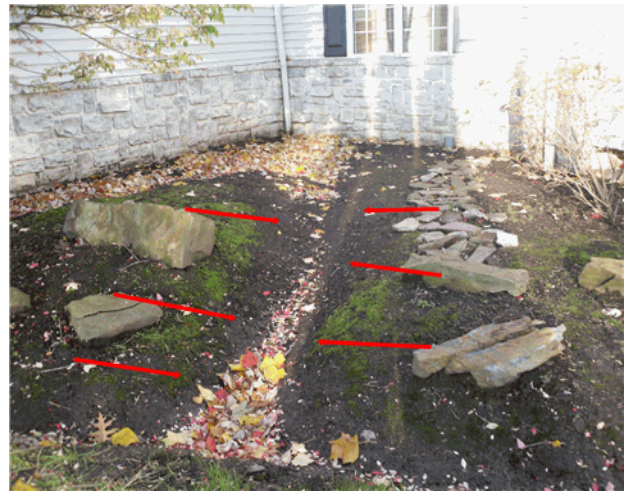
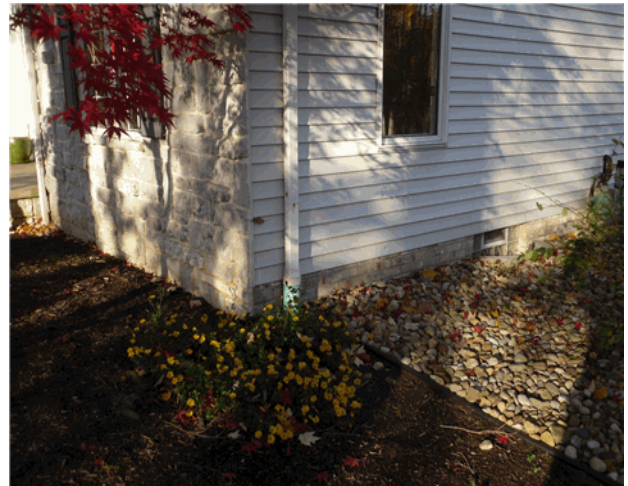
1) Grading Conditions

Poor grading near the foundation was observed. We recommend re-grading to assure all water drains away from the home's foundation. Failure to re-grade low-lying areas at the foundation can cause water seepage under slabs, into the basement / crawlspace, and / or cracks or movement in the foundation. Poor site drainage or grading was observed. We recommend re-grading uneven areas to assure water drainage away from the house. Failure to re-grade low-lying areas at the foundation can cause water seepage under slabs, into the basement / crawlspace, and / or cracks or movement in the foundation.

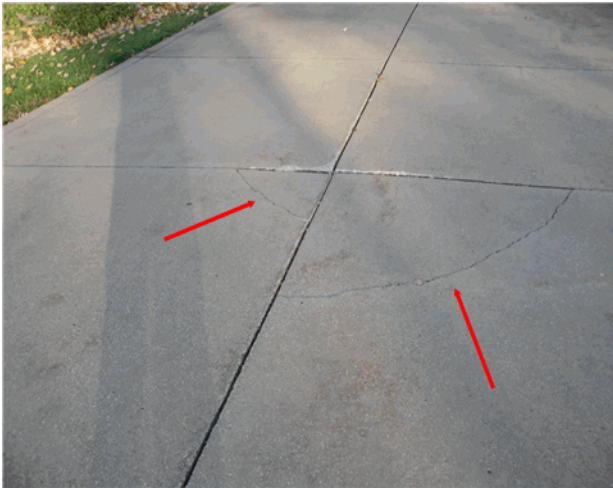
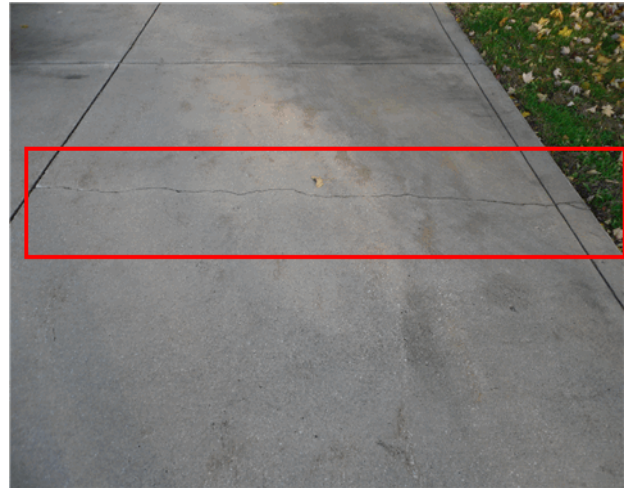
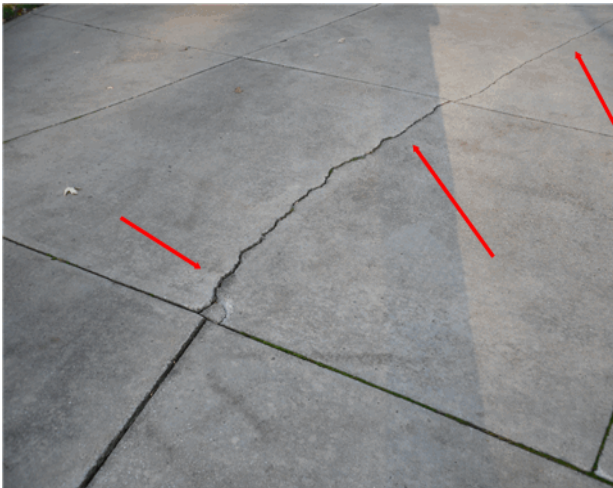
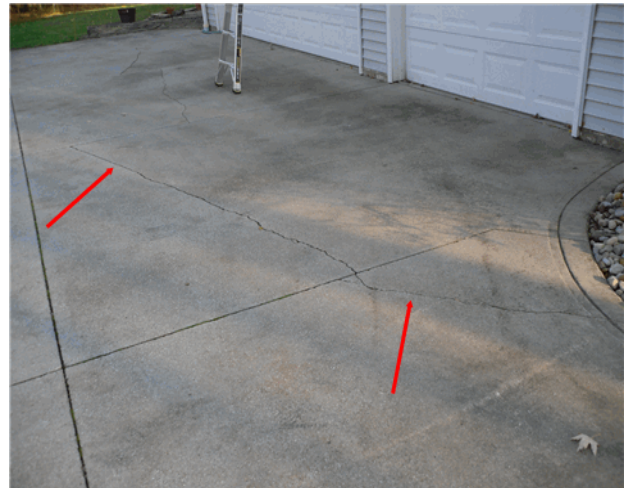
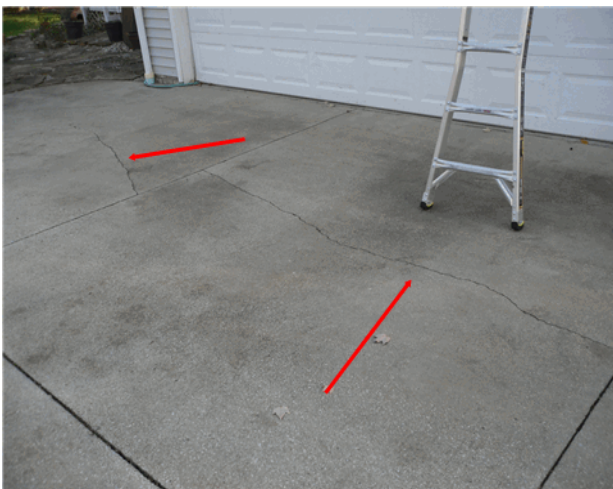
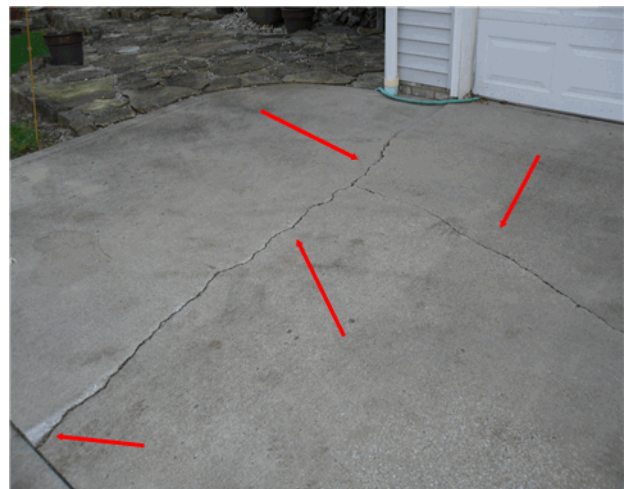
2) Driveway Conditions

Common cracks were observed in the driveway. Common cracks and settlement were observed.

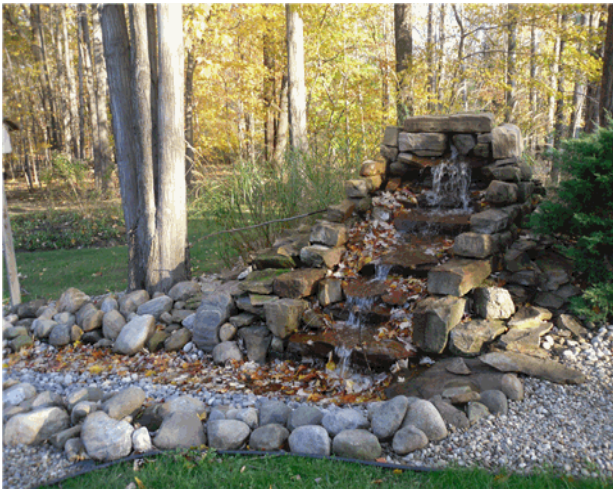
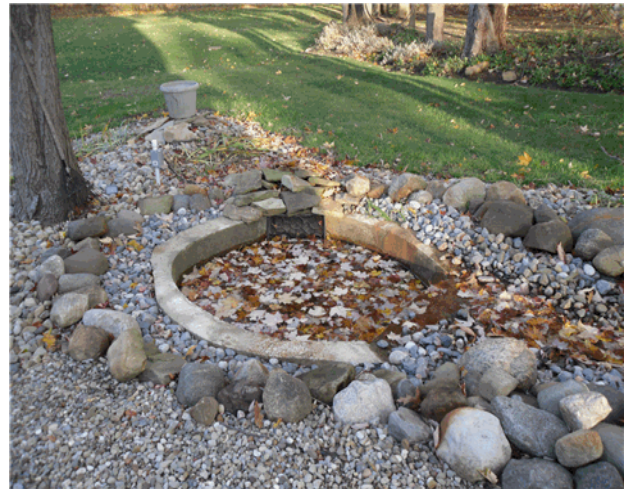
4) Retaining Wall
Conditions

The retaining wall was leaning or bowed. Some repair may be warranted. Rock on waterfall were not secured. Could be a safety issue

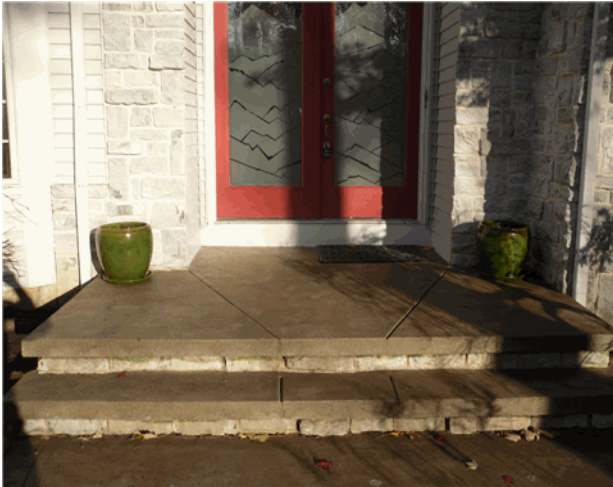
5) Front Entrance Conditions

The visible portions of the patio appeared to be in serviceable condition at the time of the inspection.

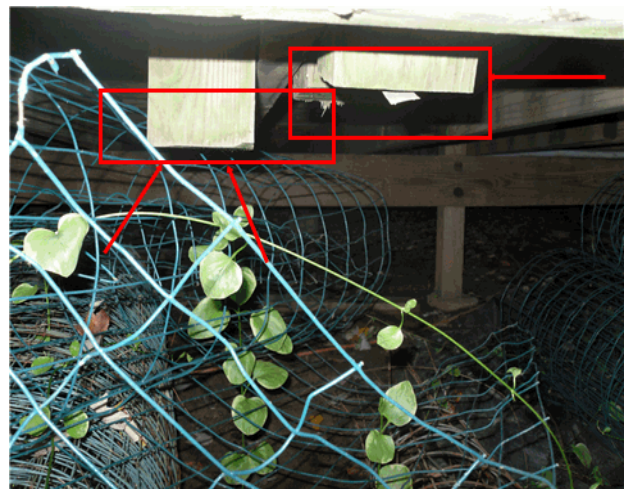
6) Back Entrance Conditions

Limited framing support was observed. While no immediate concern was noted, today's construction would require larger / additional framing. Proper footings or support should be considered to reduce any shifting or settling. The surface appeared weathered. Recommend cleaning and maintenance as needed. Bench was not connected to deck. Safety issue if someone were to sit. Recommend adding railings to avoid anyone from falling off deck.

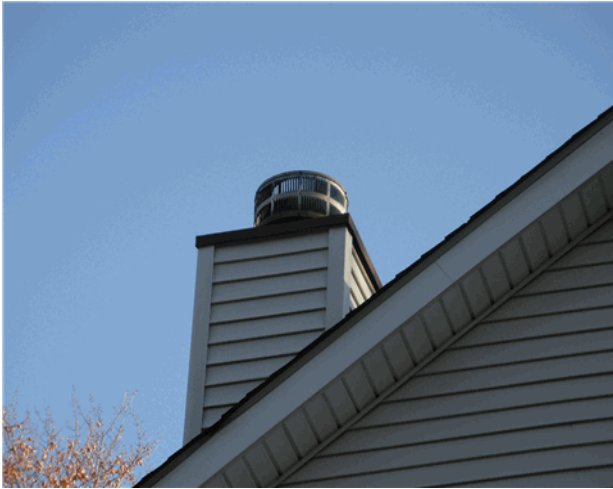
Chimney**11) Chimney
Conditions****R**

The pre-fabricated flue and / or cap was rusted.

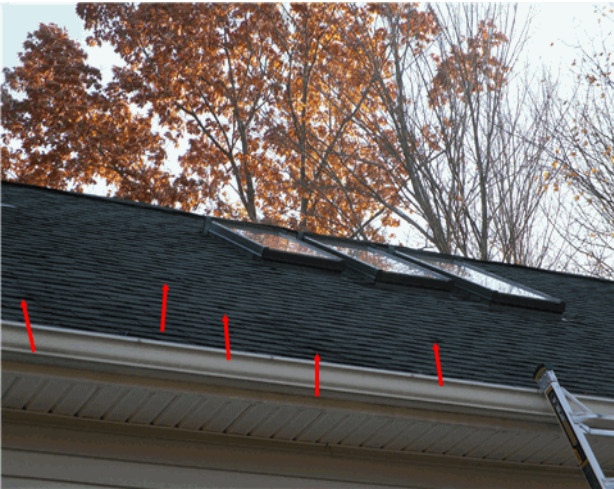
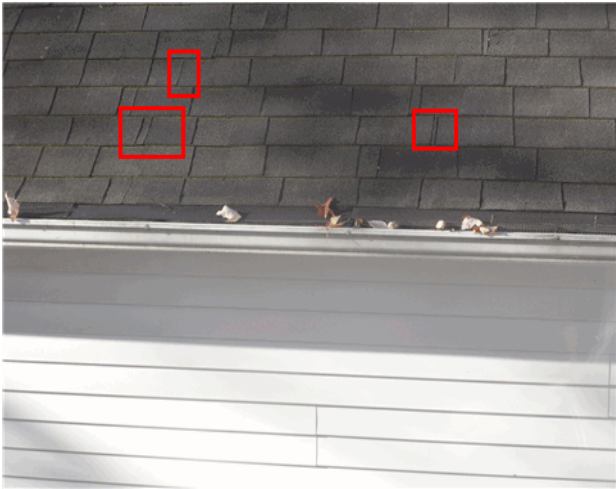
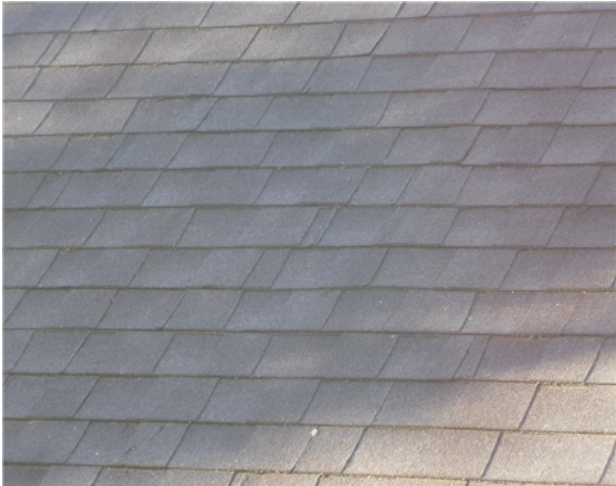
Method of Inspection	Some of the roof was inspected by observing from a ladder placed at the edge of the roof. The roof was not mounted due to the slope of the roof.
Roof Style	Gable
Roof Covering Material	Asphalt composition shingles.
Number of Layers	One
12) Roof Covering Condition	<div><div>R</div><div>The roof covering showed signs of cracking, curling, and loss of granules. This condition generally indicates that the roofing materials are approaching or close to the end of their useful life. Replacement is most likely needed. The inspector cannot offer an opinion as to whether the roof leaks today unless it is moderately raining at the time of inspection. We recommend further evaluation by a qualified roofing contractor prior to close. Client should obtain full disclosure / history information from the seller prior to close.</div></div>

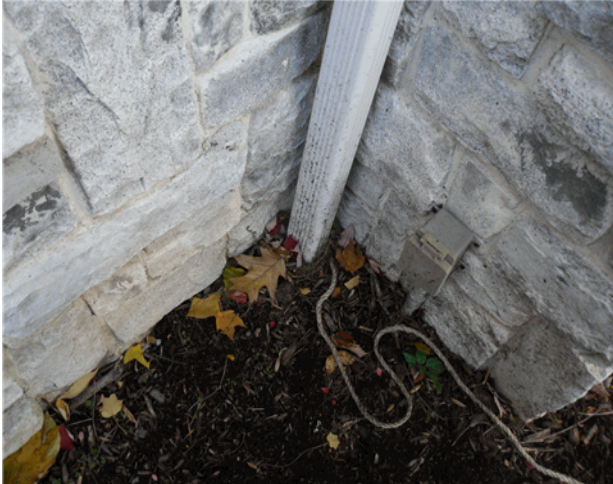
14) Gutter & Downspout Conditions

The gutter system appeared to be in serviceable condition at the time of the inspection. Recommend lowering grade so that gutter is not going into the soil. The PVC should be exposed

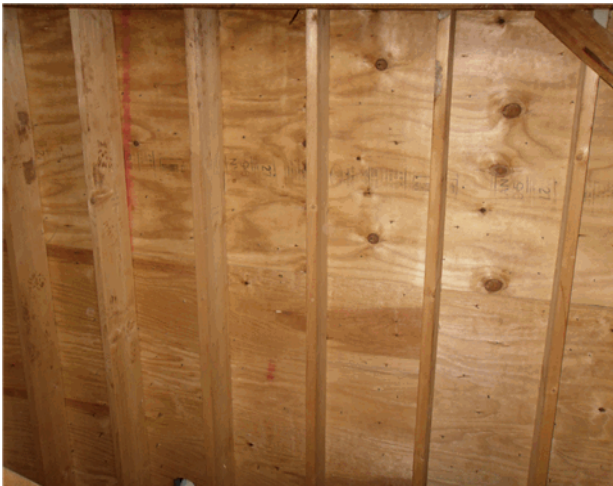
15) Attic Conditions

The visible and accessible portions of the attic appeared to be in serviceable condition at the time of the inspection.

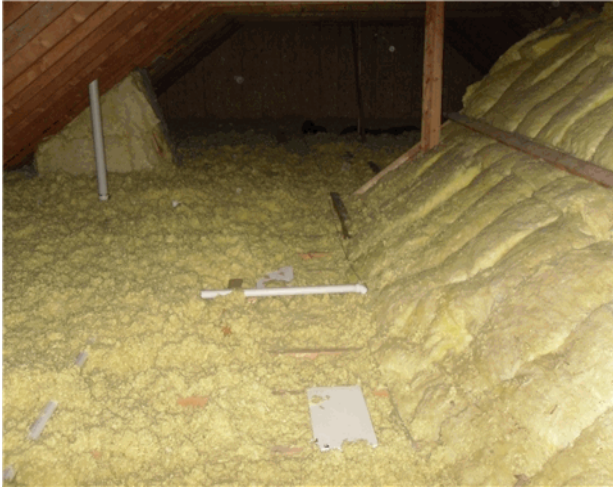
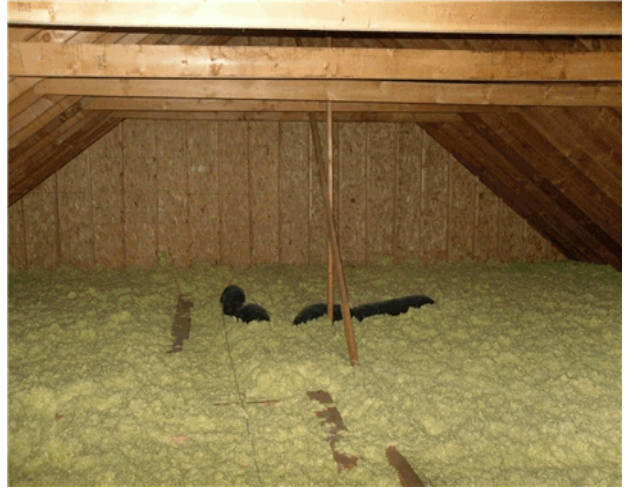
16) Attic Insulation Conditions

The attic has blown-in insulation. The approximate depth of the insulation is 10+ inches, which appears adequate. The attic has fiberglass batt insulation. The approximate depth of the insulation is 8 to 10 inches. This appears adequate.

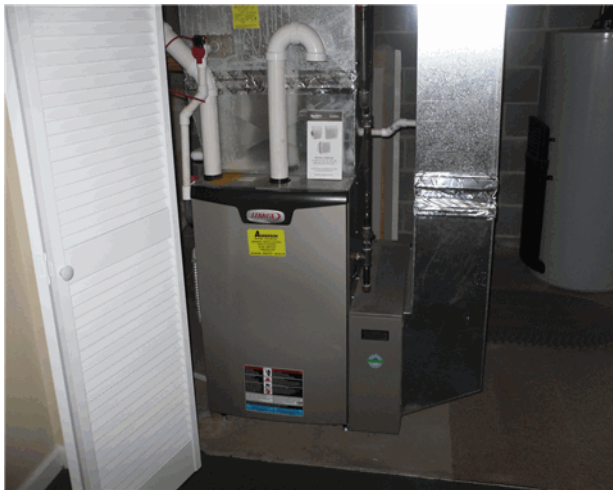
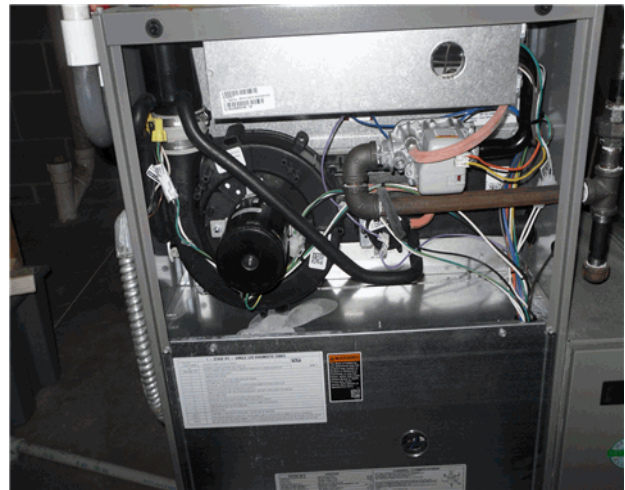
17) Unit Conditions

Two units - Forced Air. The heating systems were operational at time of inspection. This is not an indication of future operation or condition. Property disclosure says replacement in 2014 and 2017. Recommend servicing as needed.

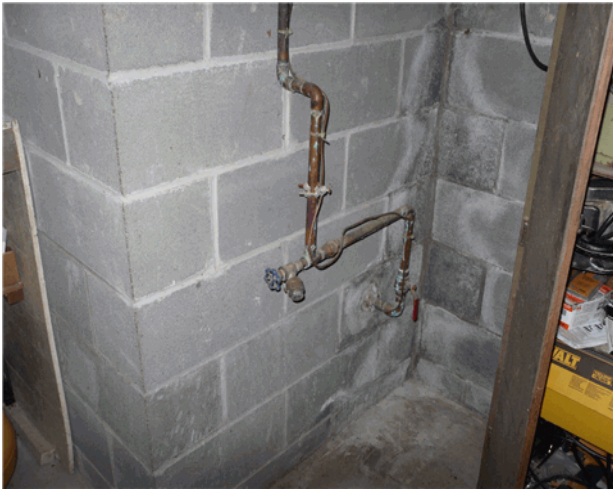
25) Main Line & Valve Conditions AS The visible portion of the main pipe and valve appeared to be in serviceable condition at the time of the inspection.

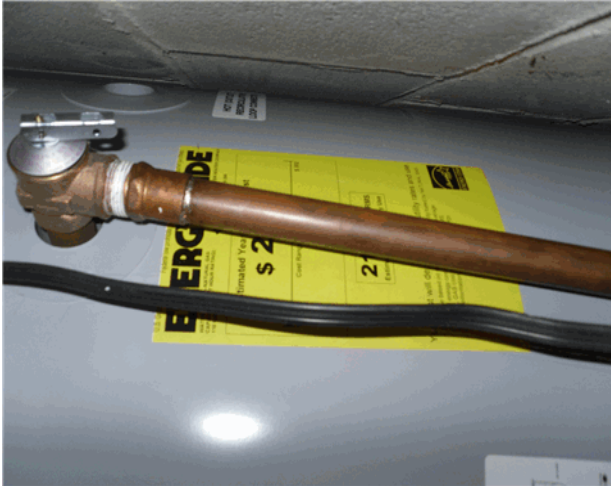
28) Water Heater Conditions AS The water heater was operable at the time of inspection. This does not however guarantee future performance, operation, or condition.

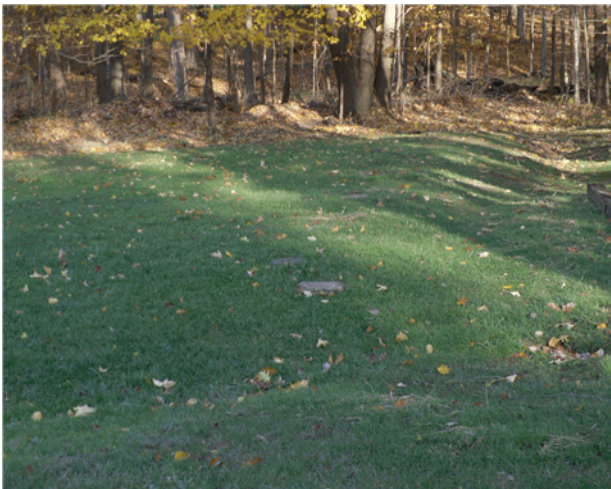
29) Condition

Not Inspected - General Inspections do NOT include septic tank inspections. However, there does seem to be some newly planted grass around the area. Recommend contacting seller to find out any details of maintenance and/or replacement, etc.

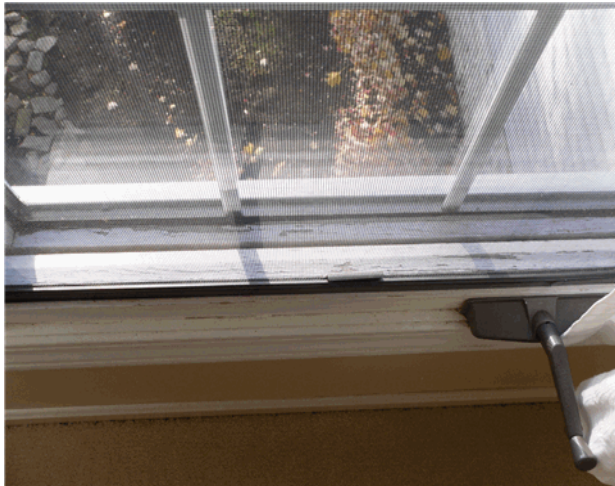
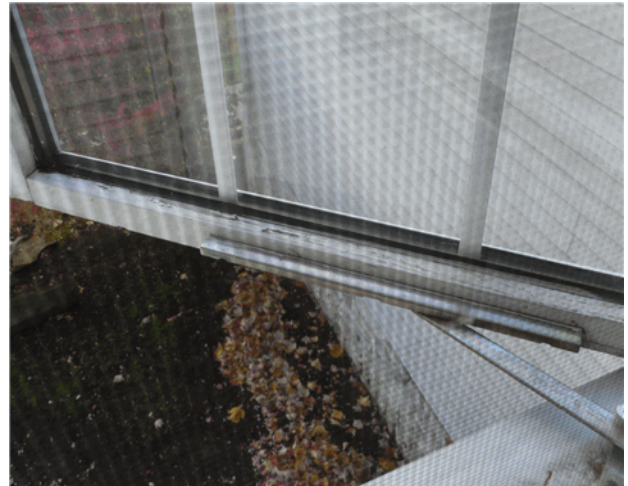
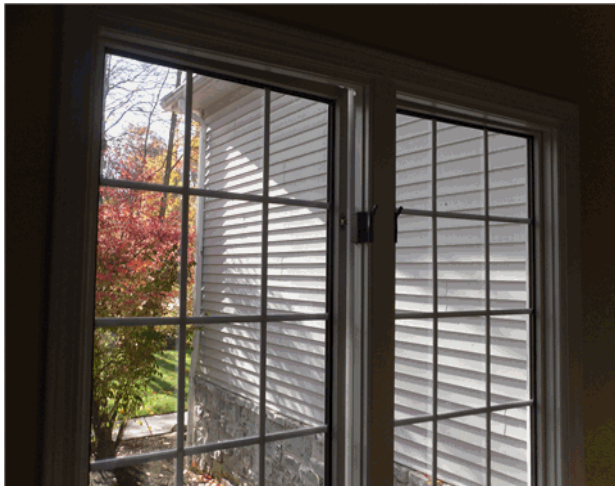
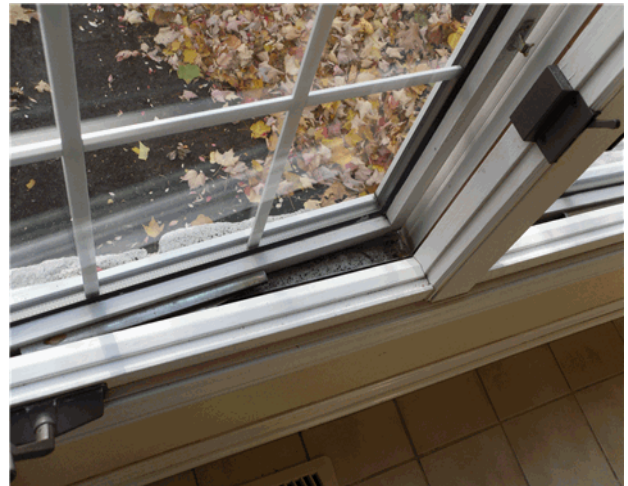
Some of the window screens were missing or not installed at time of inspection. The windows would only remain in the open position. Recommend repairs as needed. Laundry room window would not close/open. Window in office has what looks to be rotted wood. It is suggested that a "Licensed General Contractor" be contacted for further evaluation and repair.

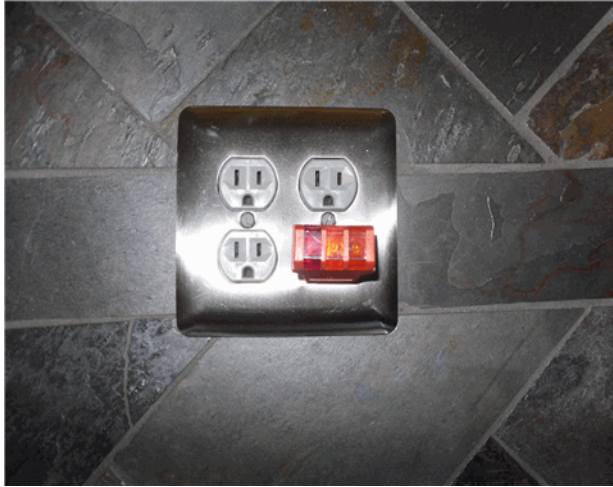
Improper wiring at outlet in living room on floor. It is suggested that a "Licensed Electrical Contractor" be contacted for further evaluation and repair.

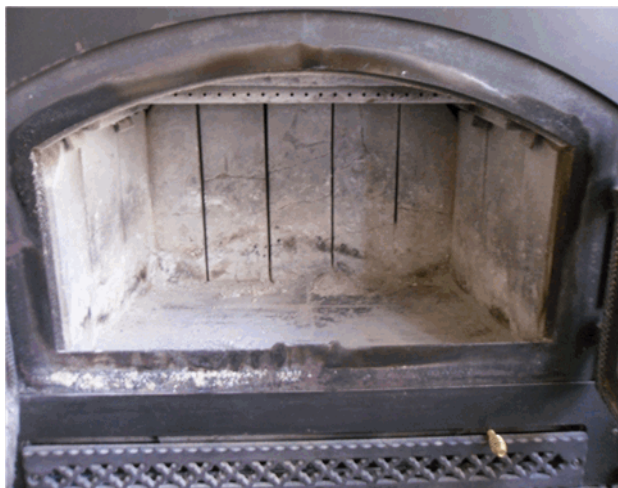
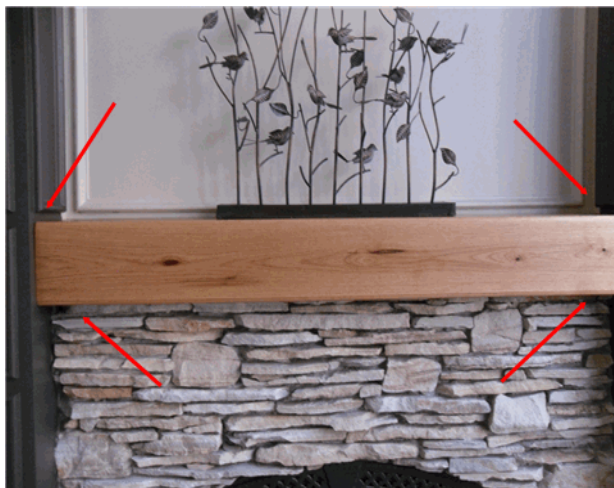
The general condition of the visible and accessible areas of the fireplace appeared to be in serviceable condition at the time of the inspection. It is suggested that a "Licensed Masonry Contractor" be contacted for further evaluation and repair. The mantle over the fireplace was loose. It is suggested that a "Licensed General Contractor" be contacted for further evaluation and repair.

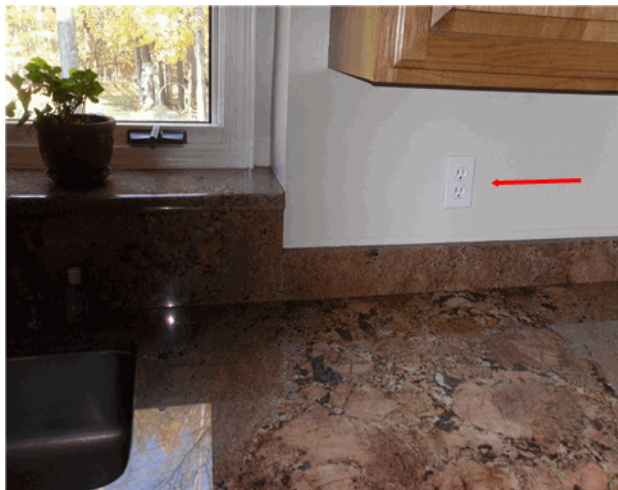
- 47) Electrical Conditions R The GFIC (ground fault interrupter circuit) receptacle needed in kitchen that is close to any water. Recommend further evaluation and / or repair by a licensed electrician prior to close.

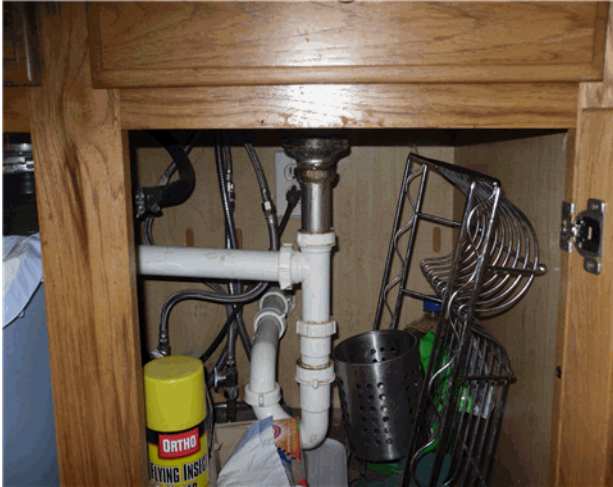
52) Sink Plumbing Conditions**AS**

The kitchen sink appeared to be in serviceable condition at the time of the inspection. The faucet appeared to be in serviceable condition at the time of the inspection. The visible areas of the plumbing under the kitchen sink appeared to be in serviceable condition at the time of the inspection.

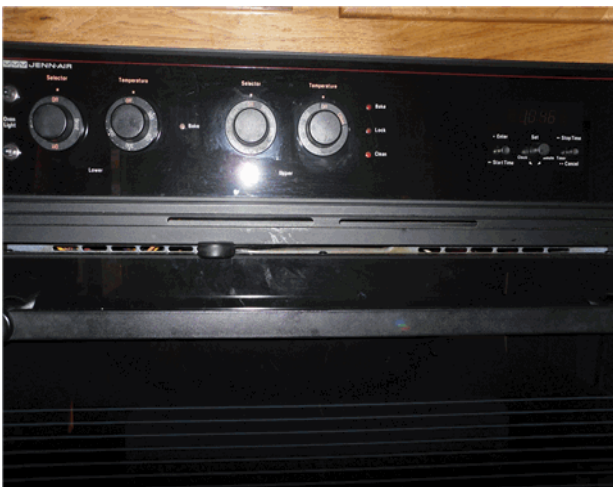
54) Stove - Range Condition**AS**

The oven was in operational condition at the time of the inspection. This does not however guarantee future conditions after the time of inspection. Noticed that the safety lock would not stay engaged. Recommend repairs as needed.

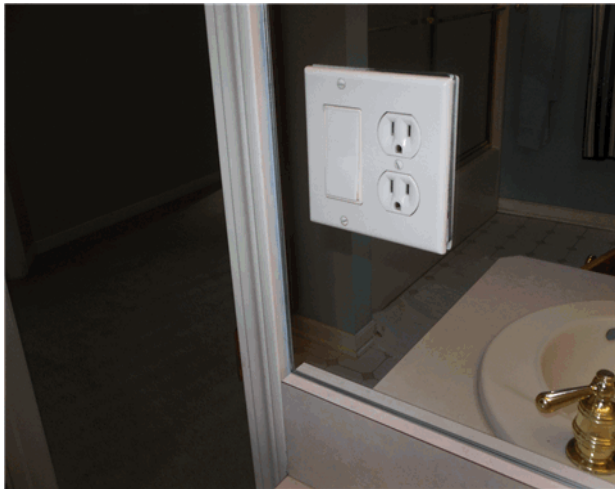
- 63) Electrical Conditions R GFCI (Ground Fault Interrupter Circuit) receptacle circuit (a safety device for outlets near water) recommended at bathroom in hall.

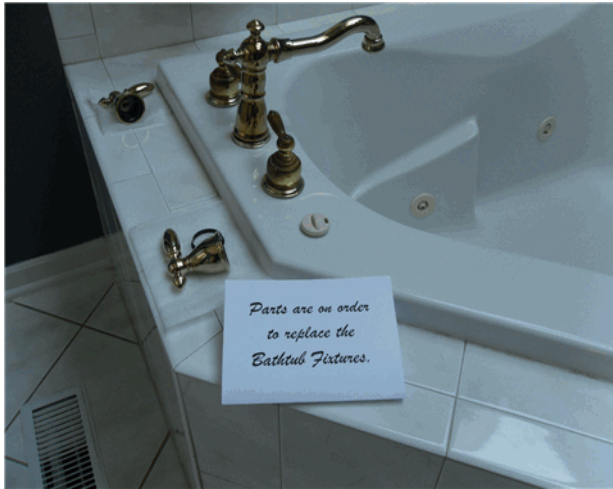
68) Shower - Tub Conditions

A whirlpool tub was noted in bath. The tub was filled to a level above the water jets. It did not operate. Pump and supply lines were not completely accessible. It is suggested that a "Licensed Plumbing Contractor" be contacted for further evaluation and repair.

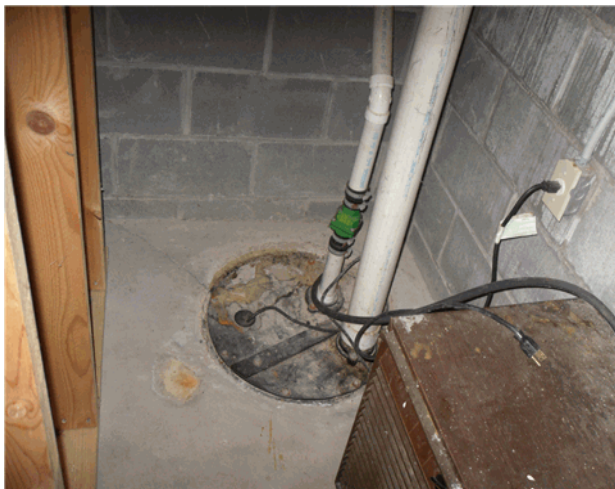
- 77) Electrical Conditions** AS Appears Serviceable
- 78) Lighting Conditions** AS Appears Serviceable
- 79) Sump Pump Conditions** AS The sump pit was sealed closed. The inspector is prohibited from disturbing the seal. The inspector was unable to inspect pit and / or pump (if present).

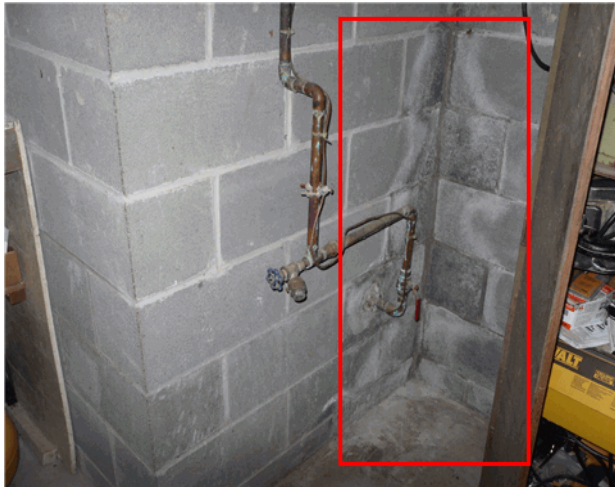
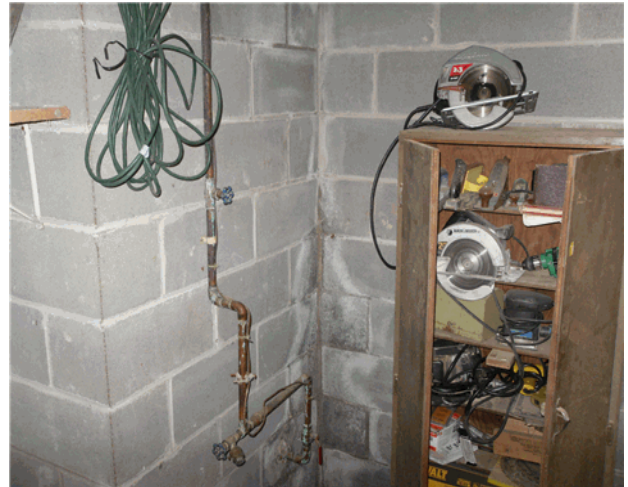
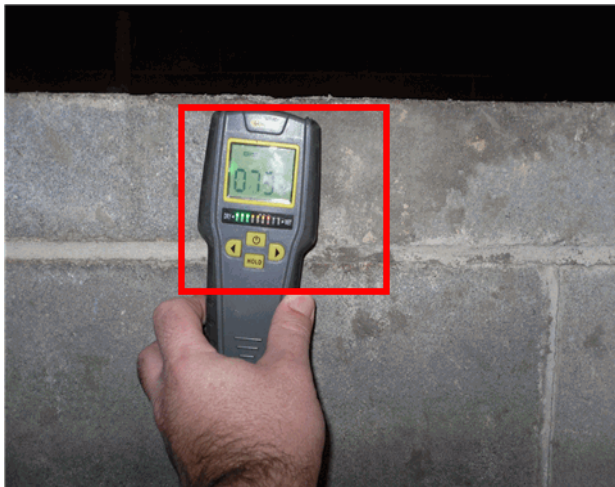
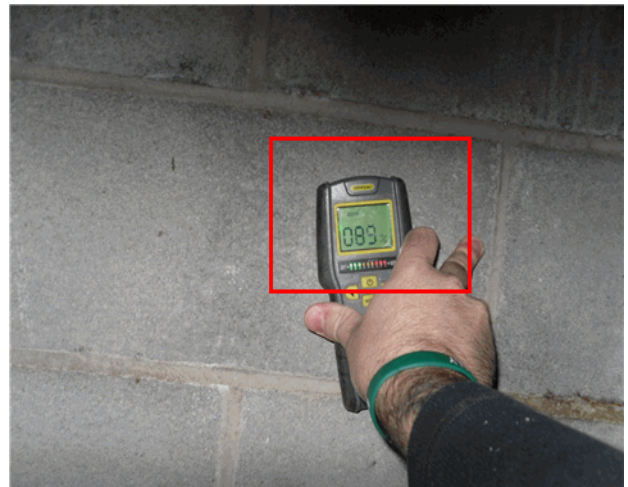
**91) Foundation
Conditions**

S Minor moisture stains were observed on the foundation walls. This may be an indication of water penetration, which is not unusual for a block foundation. The inspector was unable to determine if the water stains were active or passive at the time of inspection. Client should obtain disclosure / history information from the seller regarding any previous water penetration. Areas of moisture were observed in the crawl space. Steps should be taken to reduce moisture, such as additional vents and / or moisture barrier. The conditions observed are conducive to wood rot, mold, rust and corrosion to pipes and wires. A mold inspection or testing was not performed as part of this general home inspection.
