Inspector Report

Property Address:

873 S Main St.
Denver, CO 79854

Report Information

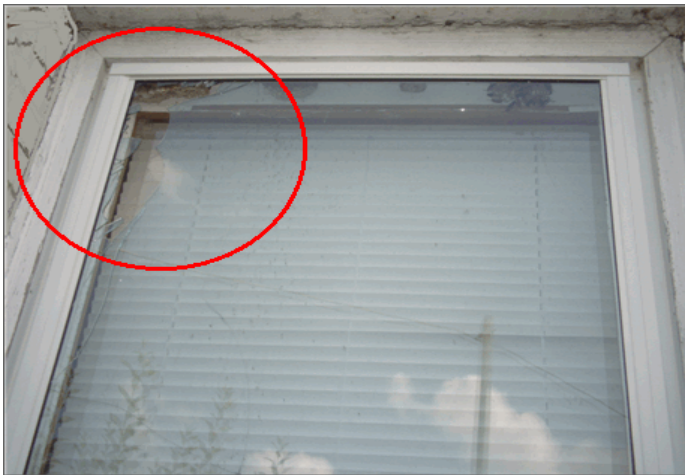
AS = Appears Serviceable**R = Repair****S = Safety****NI = Not Inspected****Exterior Windows - Doors****Window Type** Double Hung**Window Material** Wood**7) Window Conditions****R**There was a broken window at the North side of the home.
Contact a general contractor for repair.

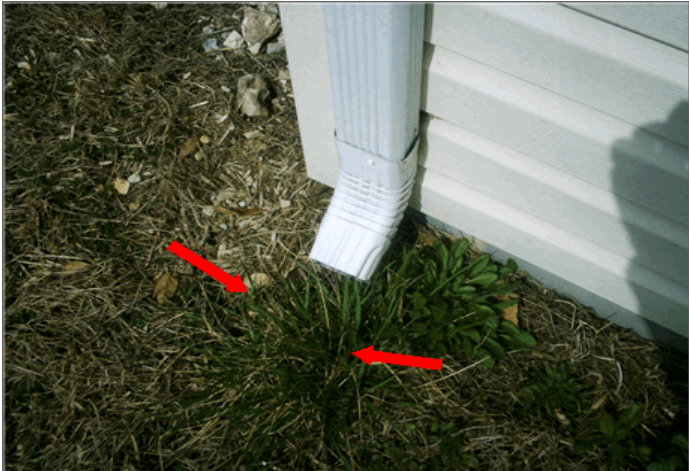
13) Gutter & Downspout Conditions

Issue 1: The downspout on the South side of the home was missing a splash plate. The splash plate helps direct rainwater away from the foundation of the home. These can be purchased at your local hardware store and are relatively inexpensive to relapse. If you're not familiar with them contact a general contractor for repair.

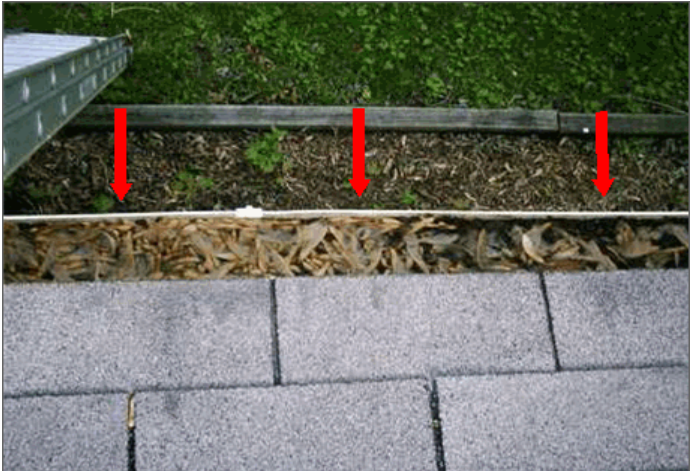
Issue 2: The gutters were full of debris. It is recommended that the gutters be cleared of debris so that rainwater can flow properly. Contact a general contractor for repair.

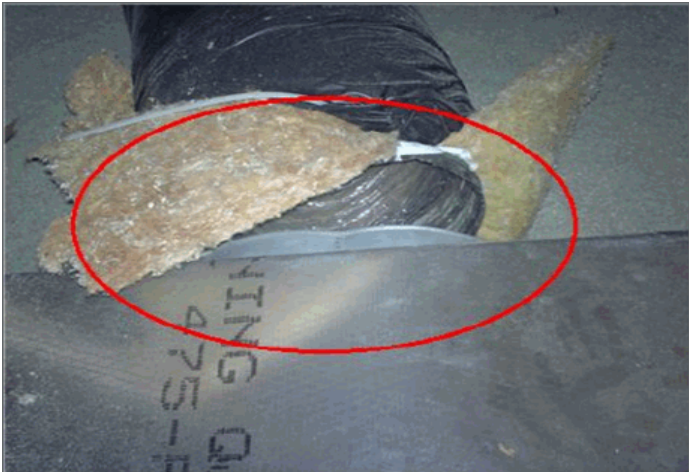
19) Distribution Conditions

Safety Issue: The cool air return vent in the attic was disconnected from the furnace. This means that the furnace is sucking unfiltered air from the attic space and distributing it throughout the home. The insulation and dust may pose a health hazard. This condition will also significantly reduce the efficiency of the furnace. It is recommended that a certified HVAC contractor be contacted as soon as possible for repair.

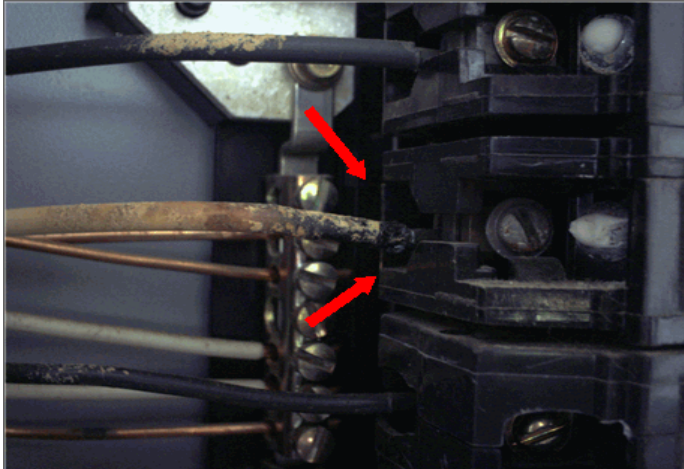
AS = Appears Serviceable**R = Repair****S = Safety****NI = Not Inspected****26) Electrical Panel Conditions****S**

Safety Issue: There were some charred wires in the main electrical panel which is an indication of overheating. this is considered a fire safety hazard and should be repaired as soon as possible. Contact a certified electrician for repair.

Electrical	26	Safety Issue: There were some charred wires in the main electrical panel which is an indication of overheating. this is considered a fire safety hazard and should be repaired as soon as possible. Contact a certified electrician for repair.
Plumbing	31	Safety Issue: The TPR Valve was missing a discharge pipe that extends to within 6" of the floor. this may pose a safety hazard if the water heater were to discharge hot water. Contact a certified plumber for repair as soon as possible.
Kitchen	56	The garbage disposal appeared to be leaking. Contact a certified plumber for repair.
Basement	75	Safety Issue: The basement stairs were missing handrails. this is considered a safety hazard. Contact a general contractor for repair.
Foundation - Crawl Space	97	Issue 1: There appeared to be termite damage on several of the floor joists in the basement. Contact a certified contractor for repair. Issue 2: There was evidence of active termites in the basement area. It is recommended that a termite inspection be performed. Contact a certified pest inspector for further evaluation and an estimate of damage.

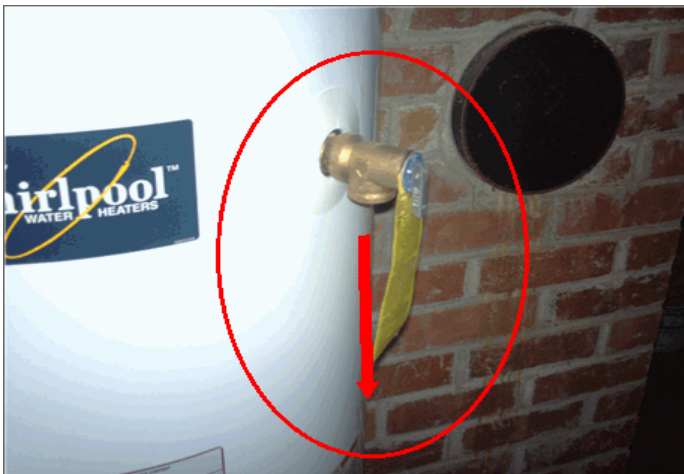
31) Water Heater Conditions

Safety Issue: The TPR Valve was missing a discharge pipe that extends to within 6" of the floor. this may pose a safety hazard if the water heater were to discharge hot water. Contact a certified plumber for repair as soon as possible.

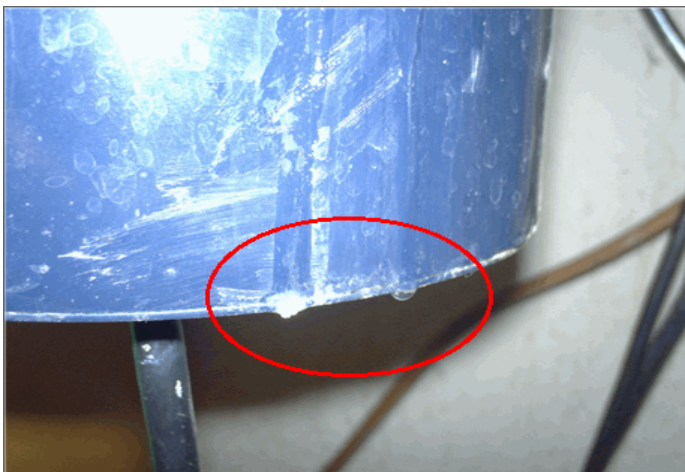
56) Garbage Disposal Condition

The garbage disposal appeared to be leaking. Contact a certified plumber for repair.

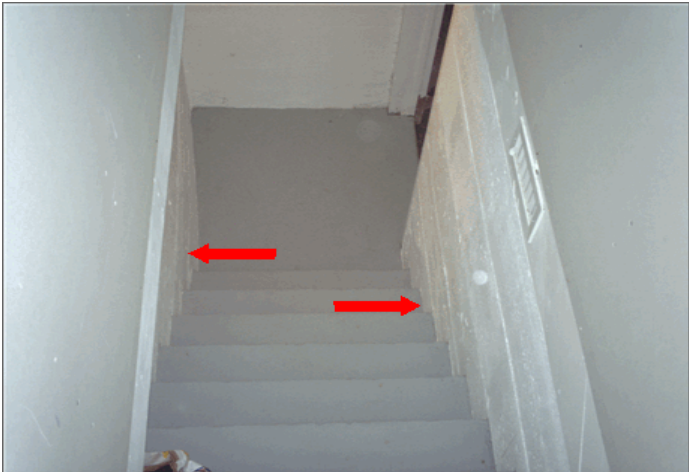
75) Basement Stair Conditions

Safety Issue: The basement stairs were missing handrails. this is considered a safety hazard. Contact a general contractor for repair.

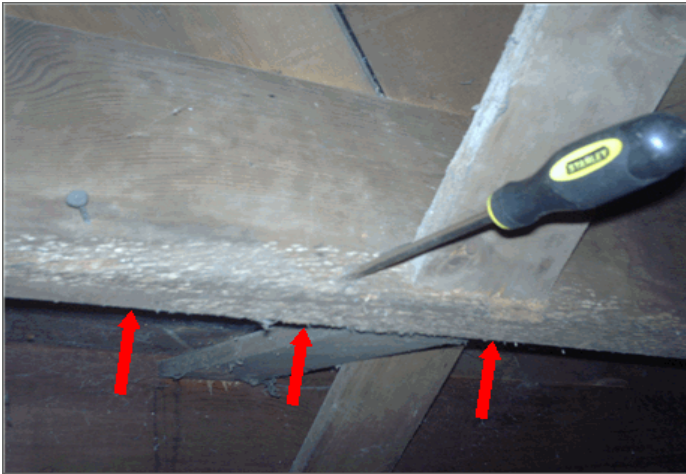
97) Flooring Support Conditions

Issue 1: There appeared to be termite damage on several of the floor joists in the basement. Contact a certified contractor for repair.

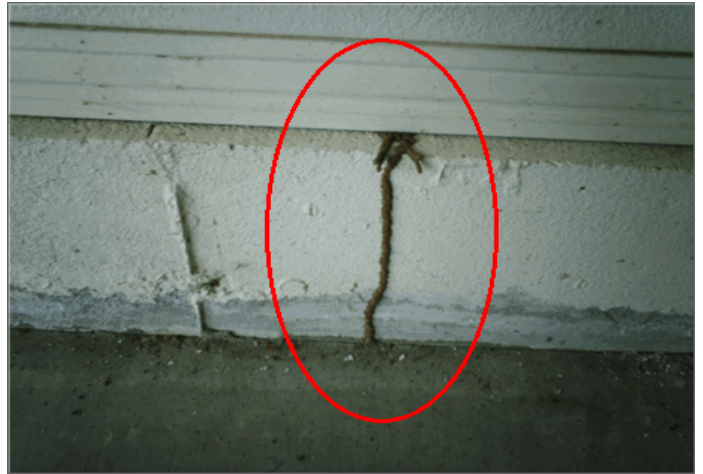
Issue 2: There was evidence of active termites in the basement area. It is recommended that a termite inspection be performed.

Contact a certified pest inspector for further evaluation and an estimate of damage.
